Case Study

Iron Ore Mine, South Africa

LinaShield

PRODUCT:	LinaShield Thermoplastic Polyurethane Wear Liners
LOCATION:	Iron Ore Mine, South Africa
PRODUCT DESCRIPTION:	10mm LinaShield glued to 10mm mild steel backing plate
SHORE A HARDNESS:	85°
APPLICATION:	Wear plates on a washing and screening vibrating panel
MAXIMUM PARTICLE SIZE:	80mm rocks
INSTALLATION DATE:	January 2020
TEST RESULT:	Successfully installed (Wear Life to be determined)

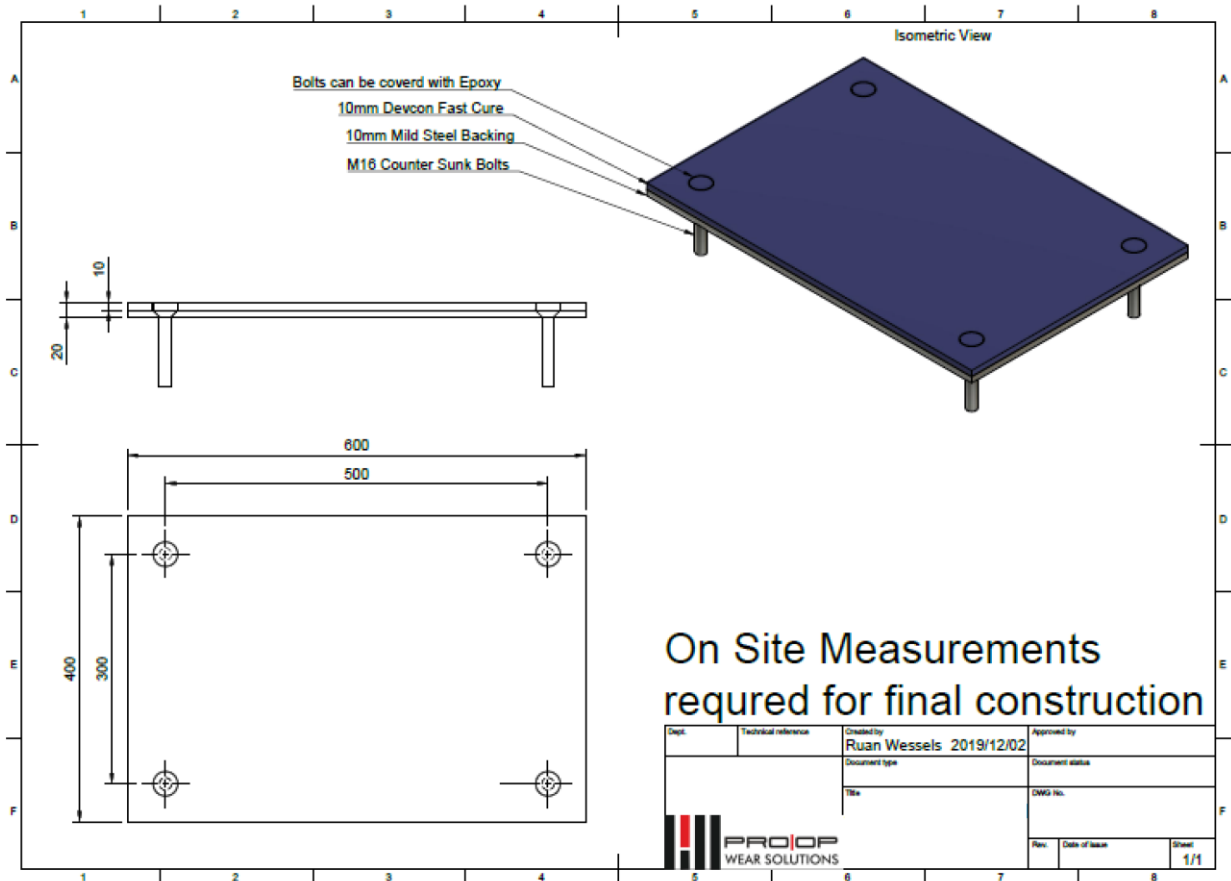
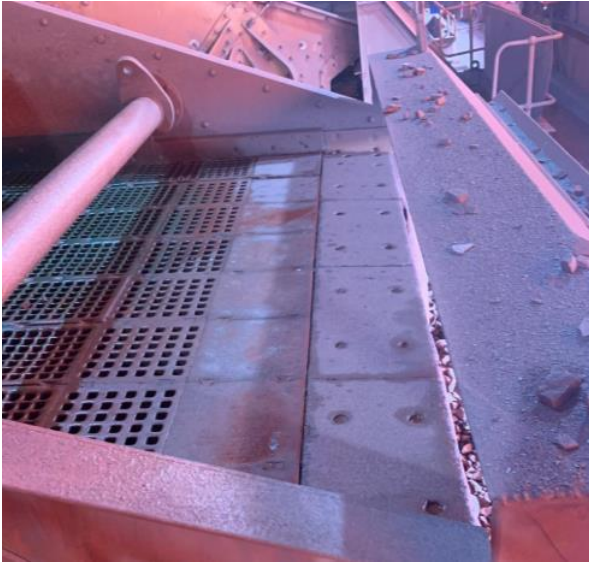
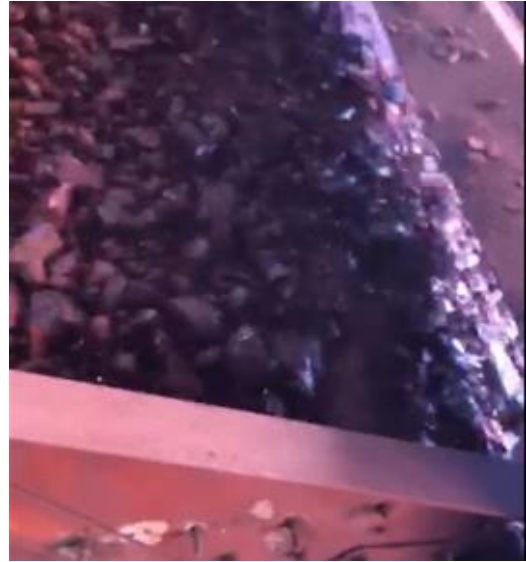
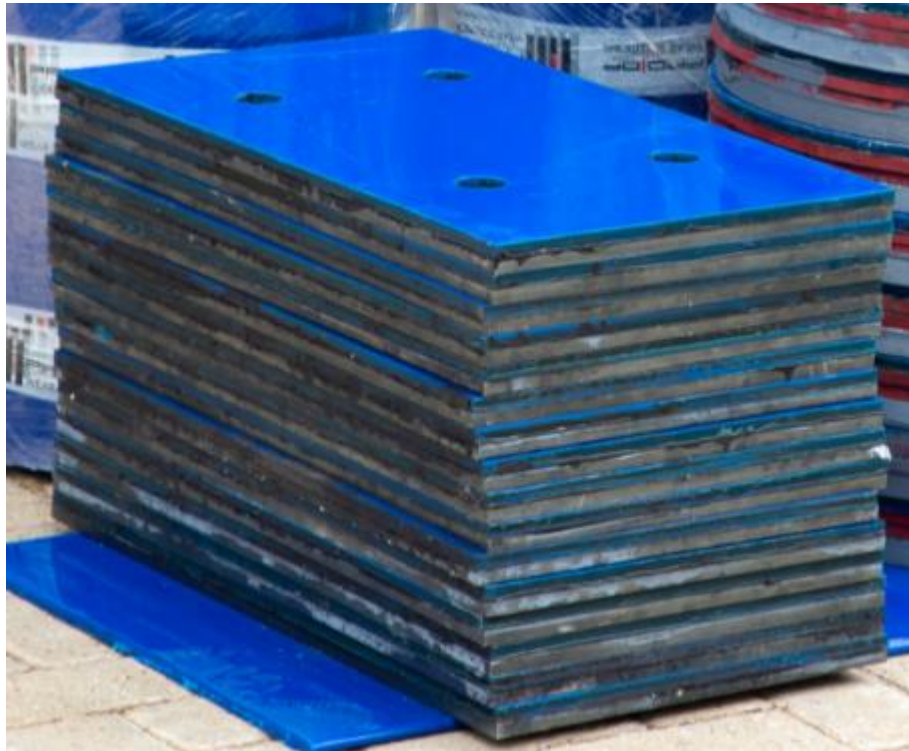
IMAGES & DRAWINGS:

LinaShield 10mm was glued to a 10mm backing plate. The glue used was Topstick PL.

LinaShield was installed on the vibrating screen where highly abrasive rocks slide. The plates were successfully manufactured and installed.

Successfully manufactured and installed. The wear life is still to be determined. (Update to follow)
